Bible Hill Sanitary Sewer System Study Final Report

March 18, 2021

Prepared for:
Village of Bible Hill

RVA 205335

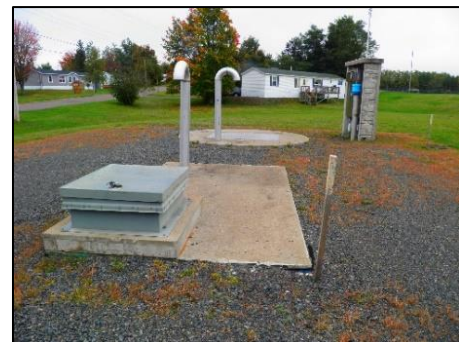
PS02 – Recreation Park

Overall, the Recreation Park pumping station is in Good condition and requires very little attention. The station is well maintained and cleaned regularly. There is some grease build up at the normal start level on the inside perimeter of the wet well chamber. Float sensors (2) have been replaced recently but transducers may require calibration.

The pump drawdown assessment indicates both pumps are performing adequately. It is noted at the time of drawdown inflow to the station was occurring, as such actual drawdown depth in the wetwell is expected to be slightly greater than that observed.

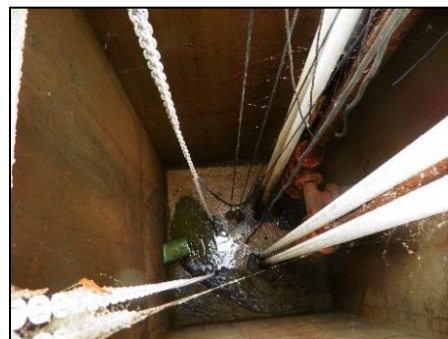
Overall, the Osprey Ridge pumping station is in Fair condition. There are some apparent issues with Pump No. 2, affecting its capacity to discharge sewerage. In addition to the issues observed with Pump No. 2, the valves in the station are beginning to show significant rust and should be cleaned and painted.

The pump drawdown assessment indicates Pump No. 2 is not performing adequately. Pump No. 1 appears to drawdown the wet well however not at the rate identified on the pump curve. During the drawdown test inflow was observed, as such actual drawdown may have been slightly greater. When comparing drawdown to the performance curve it was found that Pump No. 1 does not discharge in accordance with the expected rate and additional investigation is required.

| Recommendation | Cost |
|--|---|
| Fix seal leak at frame of valve chamber. | \$3,000 |
| Replace safety grating. | \$3,500 |
| Replace pump No. 2. | \$20,600 |
| Replace panel | \$55,000 |
| Replace level sensors. | \$3,000 |

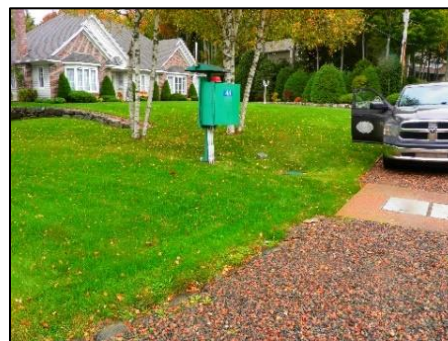
PS19 – Somerset

Overall, the Somerset pumping station is in Poor condition and several components require replacement or major rehabilitation in the short-term. Built in 1990, most components are 30-years old with valves exhibiting significant rust and have not been operated in many years.

The pump drawdown assessment indicates whether a pump station is performing in accordance with design intent. Drawings and design information for this station is not known. The on-site pump test indicated that the pumps evacuate the wet well within a reasonable timeframe, however power draw for the motors is known to be increasing suggesting there may be wear issues with the pump and motor assemblies.

| Recommendation | Cost |
|--|---|
| Replace both pumps | \$24,000 |
| Replace guide bars | \$4,000 |
| Replace piping | \$2,000 |
| Replace bolts, brackets, and chains | \$6,600 |
| Replace access hatch and safety grating | \$5,000 |
| Replace valves and construct new valve chamber | \$17,000 |
| Replace control panel | \$55,000 |
| Replace float sensors | \$3,000 |

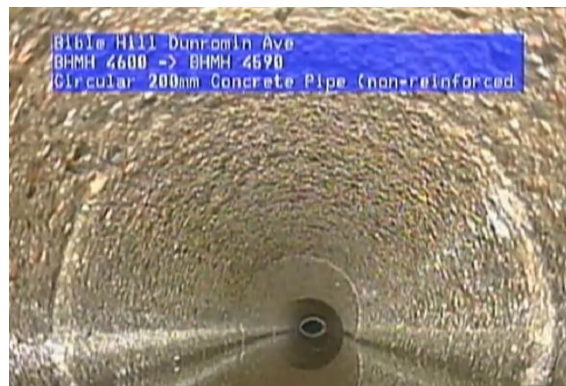
Figure 14. Example of Concrete Pipe Spalling

Despite recent CCTV inspections showing limited evidence of acute defects within older pipe segments, we do observe chronic stresses (e.g. spalling of concrete pipes, shown in Figure 14) which can increase a pipe’s likelihood of failure. Given these distresses, there is the potential that the original sanitary sewer system’s linear infrastructure will require replacement over the next 20 to 30 years. Replacement of this infrastructure should be dependent on the outcomes of regular CCTV inspections and assessments.
