Bible Hill Sanitary Sewer System Study Final Report

March 18, 2021

Prepared for:
Village of Bible Hill

RVA 205335

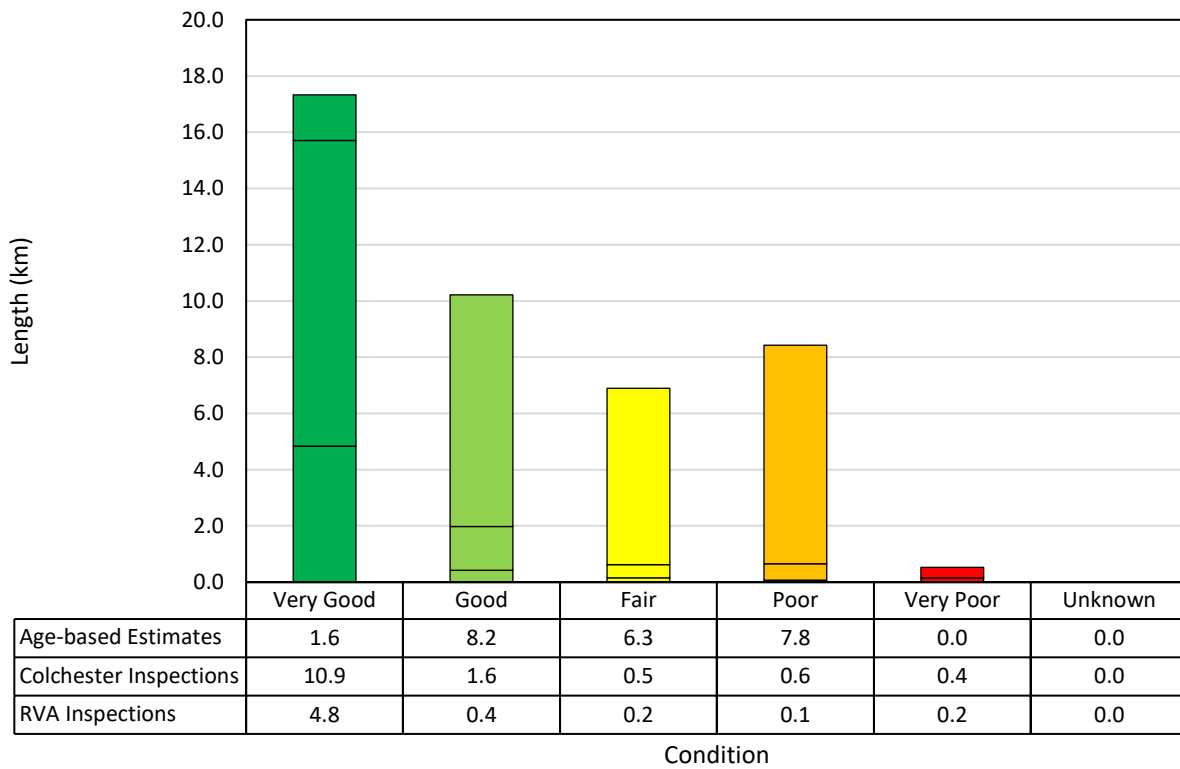
Figure 6: Sewer Condition Rating Summary

Sewer condition rating results (and the sources of data used to estimate condition) are summarized in Figure 6 and a map demonstrating the condition of each sewer is presented in Figure 8.

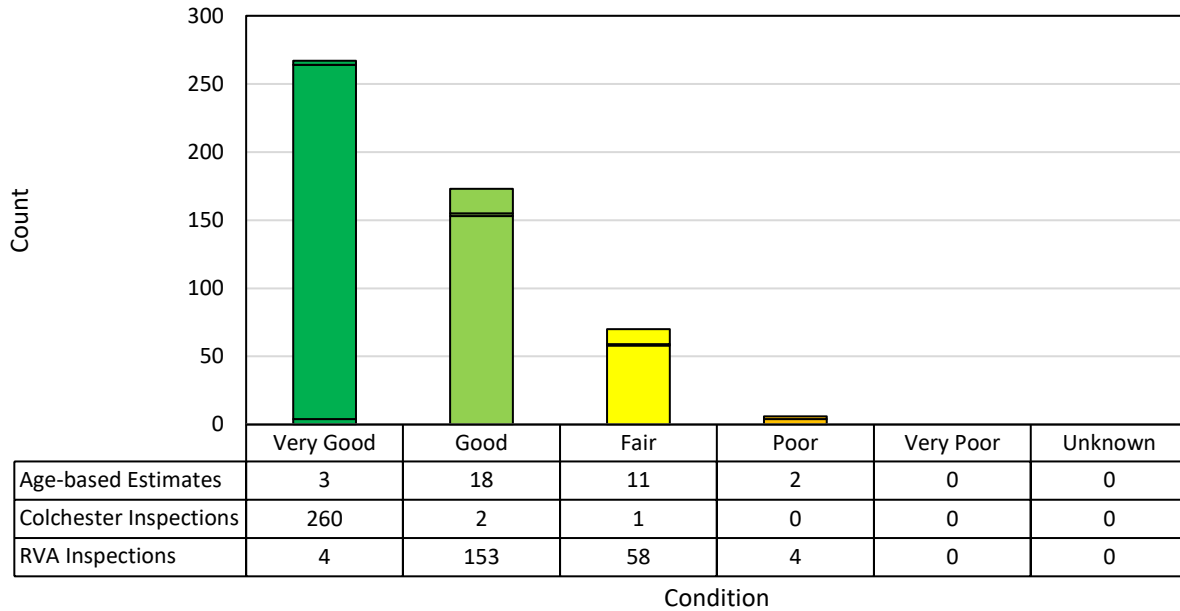
Figure 7: Manhole Condition Rating Summary

Manhole condition rating results are summarized in Figure 7 and a map demonstrating the condition of each individual manhole is presented in Figure 9.

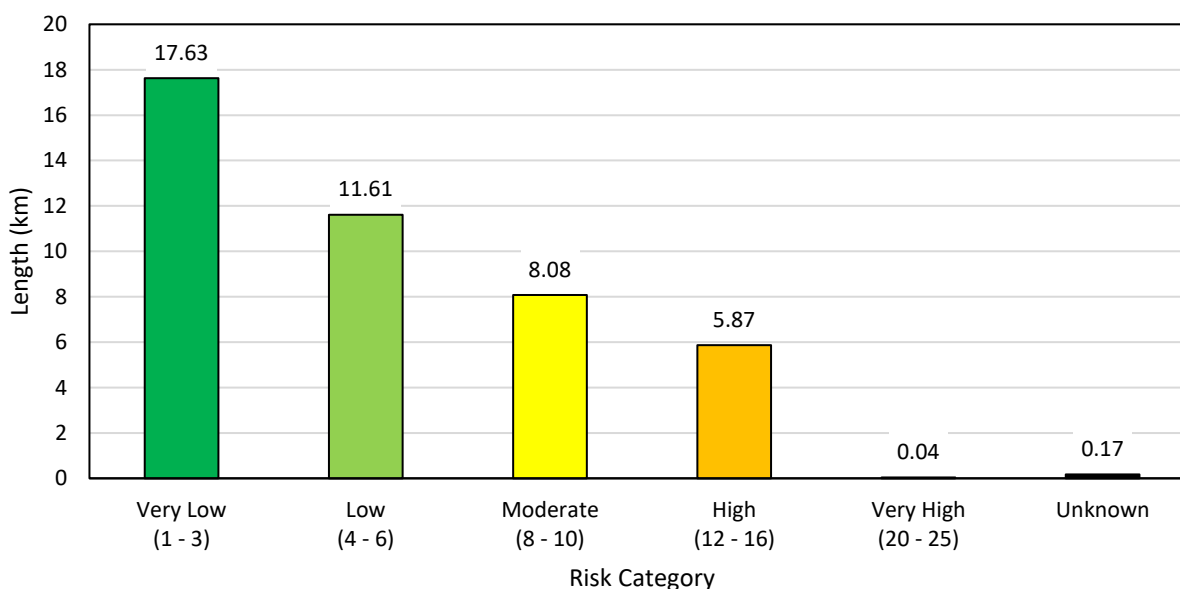
Figure 10: Sewer Risk Distribution

Overall, the Village’s sewer system exhibits a Moderate degree of risk. While 37.3 km (86%) of the Village’s sewers are in a Very Low to Moderate risk category, approximately 5.9 km (14%) of sewers exhibit a High or Very High risk. Approximately 0.17 km of sewers risks could not be estimated as the pipe diameters were unknown and were not located within 10 m of a watercourse. The single pipe segment within the Very High risk category is located at the Farnham Brook crossing, north of Coupar Terrace.

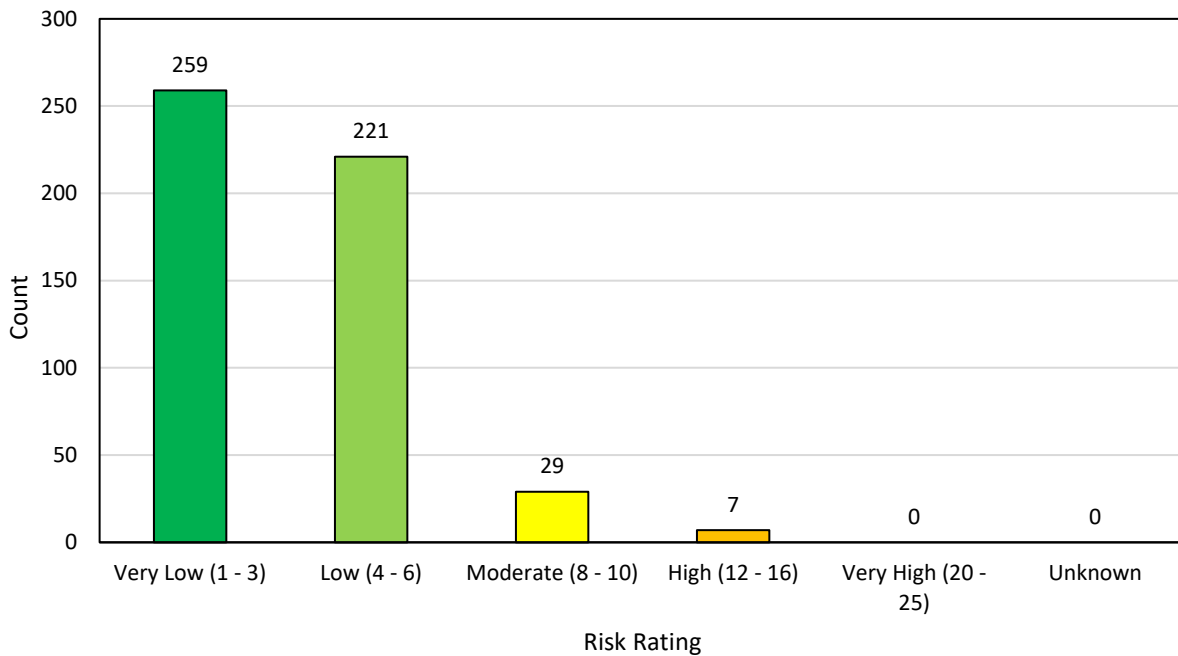
Figure 11: Manhole Risk Rating Distribution

Overall, the Village’s manholes exhibit a Low degree of risk. Based on the risk analysis completed by RVA, 480 manhole structures (93%) exhibit a Low or Very Low risk rating, while only 36 manhole structures (7%) exhibit a risk of Moderate and High. No manhole assets were found to be a Very High risk rating based on the risk rating criteria established.

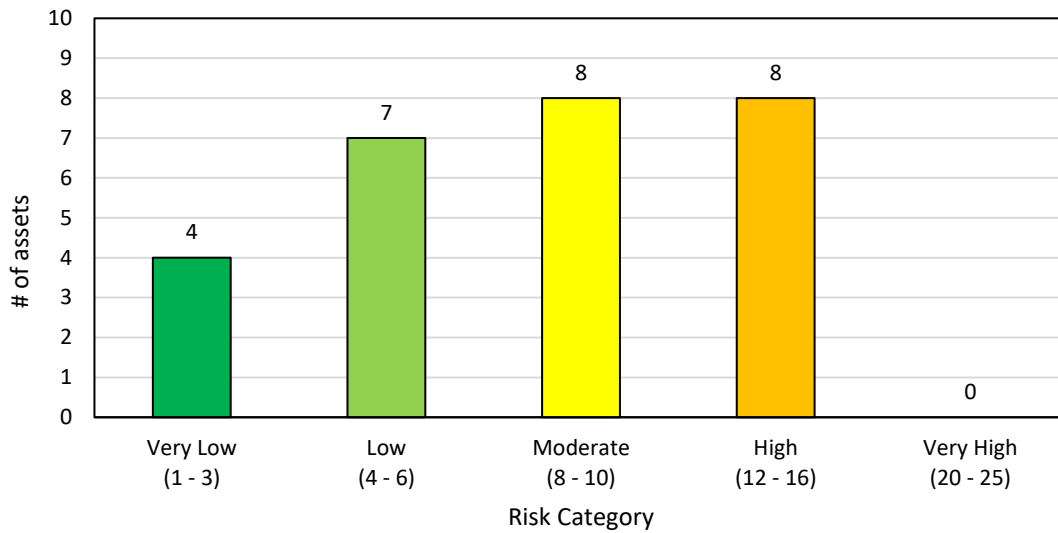
Figure 12: Pumping Station Risk Distribution

Overall, the Village's pumping stations exhibit a High degree of risk. 8 assets within the 3 stations are in a High-risk category. Notable inclusions are the Somerset station pumps & valves and Osprey Ridge station pumps & valves.
